DATE: November 29, 1982

SUBJECT: LPC #18302013 - Vermilion County - Danville/Danville Plating

LPC #18302013 - Vermilion County  
Danville/Danville Plating

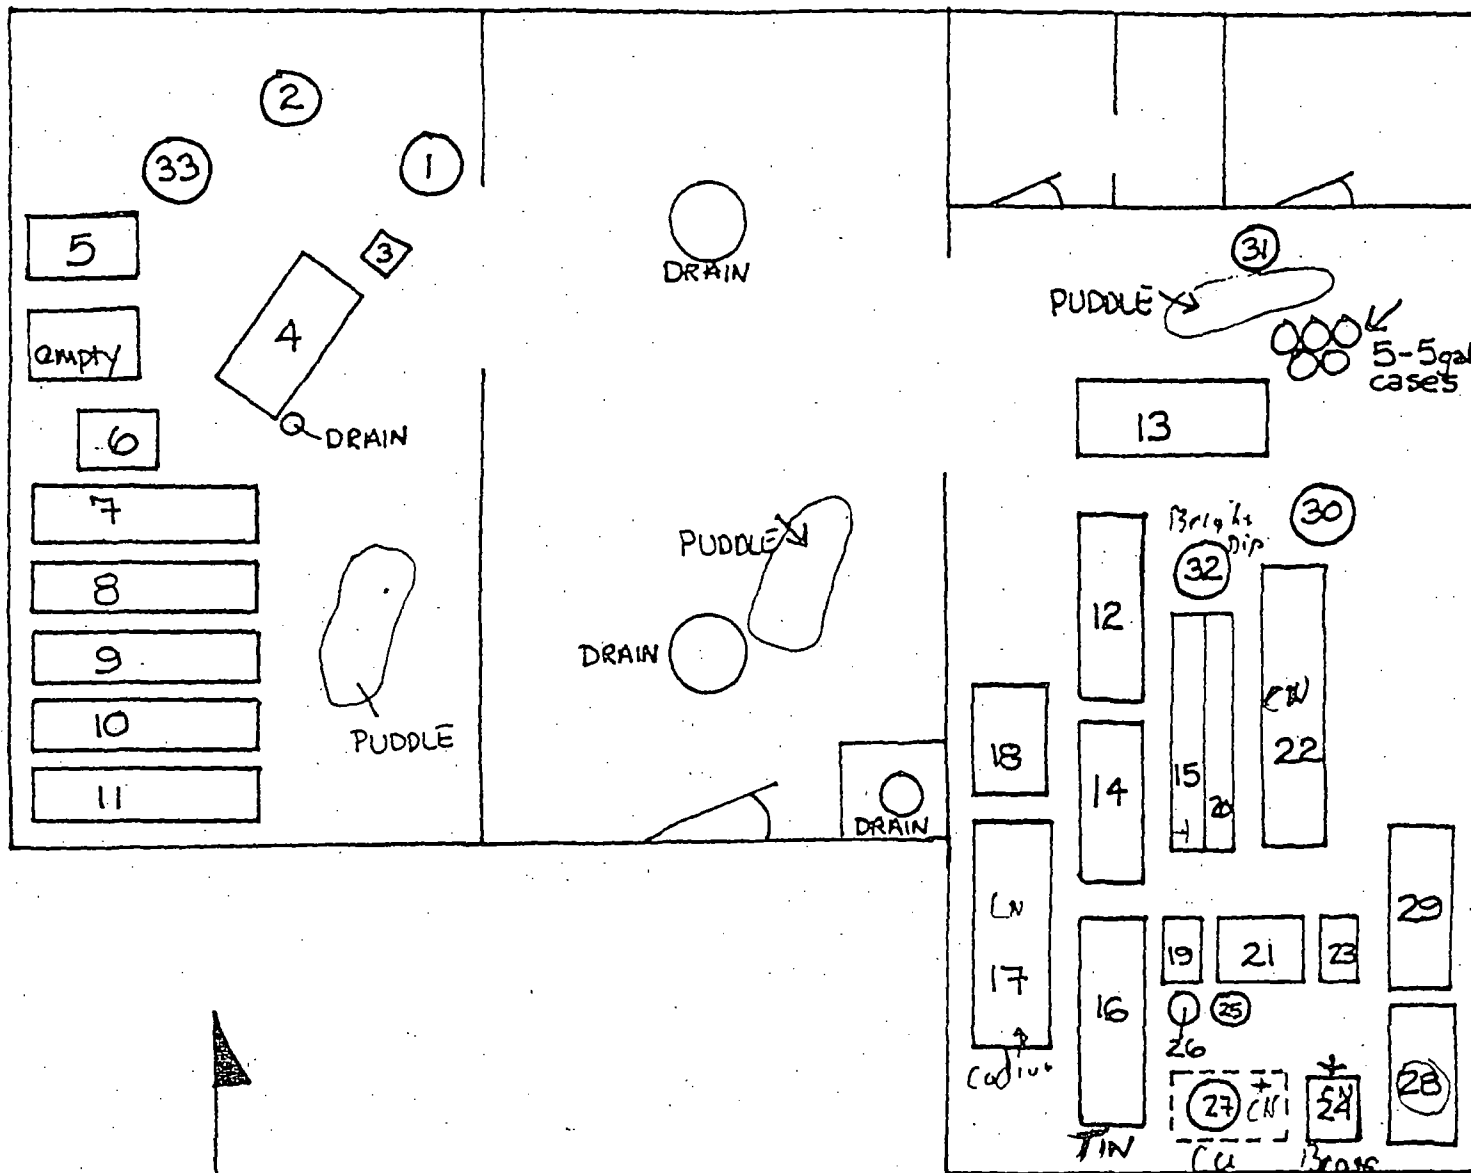
Danville Plating Company  
 307 E. Fairchild  
 11-23-82  
 S. Amendt

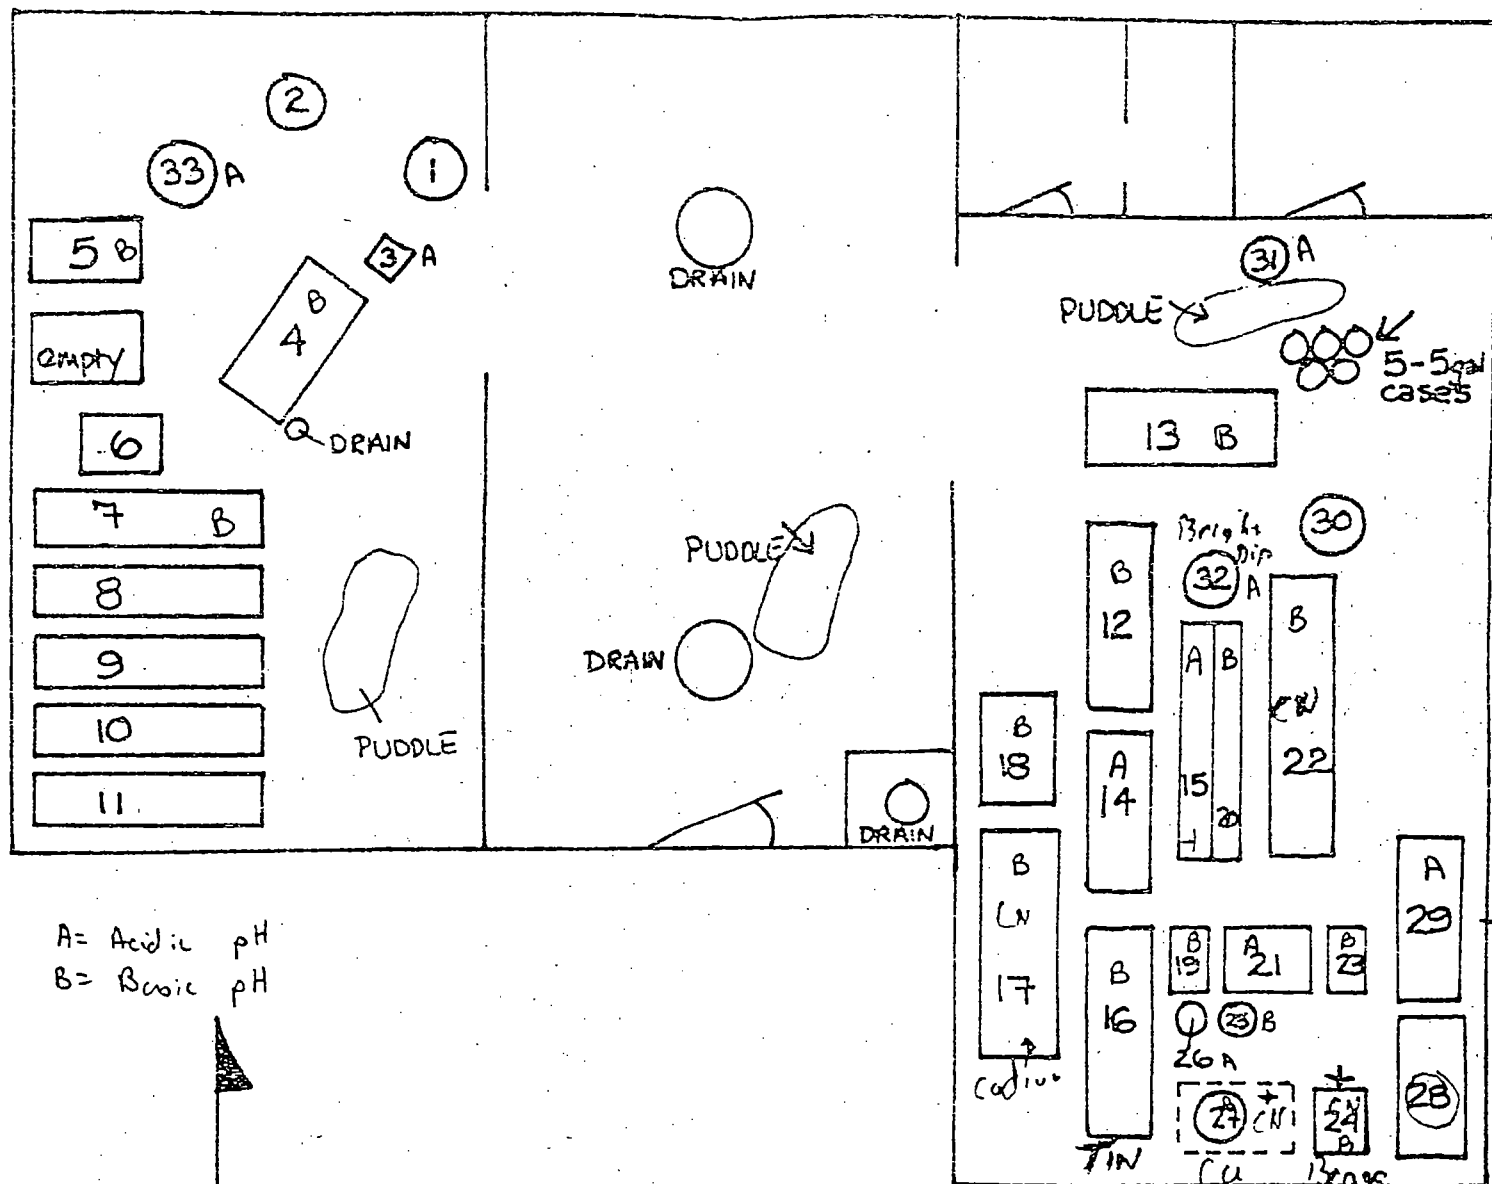
Danville Plating Company  
 307 E. Fairchild  
 11-23-82  
 S. Amendt
